BOA Architecture / Government Services
Rancho Palos Verdes ADA Assessment

Facility Report with Photos - Programs Services

Facility ID: # 02B - City Hall Buildings

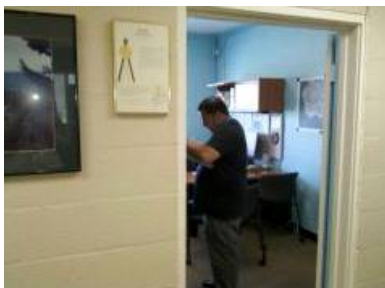
Photo #
252

Existing Condition: 77 1/2" at door

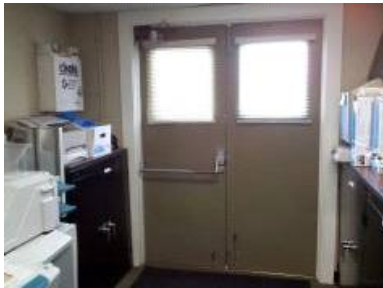
Photo #
247

10.08 - Kick Plate - Bottom 10" of door does not have a smooth, uninterrupted surface on the push side to allow the door to be opened by a wheelchair footrest without creating a trap or hazardous condition. (This requirement does not apply to automatic and sliding doors.)

Existing Condition: Door stop.

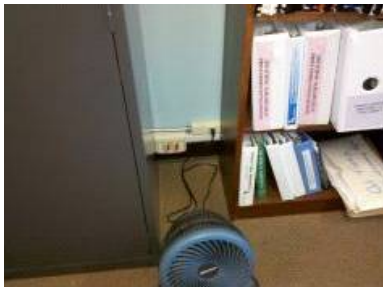
Photo #
254

Existing Condition: 2 data, 1 power strip.

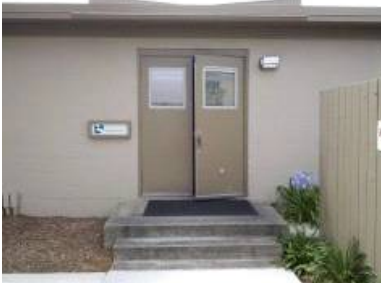
10.10 - Single-Action Hardware - Handles, locks, and latches or other operative devices are not operable with one hand and without tight grasping, pinching, or twisting of the wrist. (U-shaped handles, levers, and push/pull type mechanisms are acceptable designs.)

Existing Condition: Thumb latch.

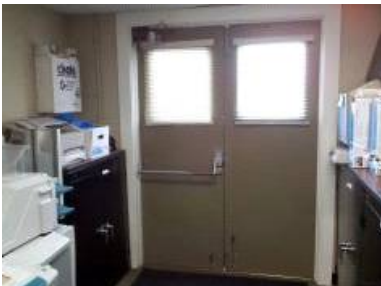
10.11B - Hardware Operating Effort - The force required to activate handles, pulls, latches, locks, and other operable parts of door exceeds 5 lbs.

Existing Condition: 6 LBF.

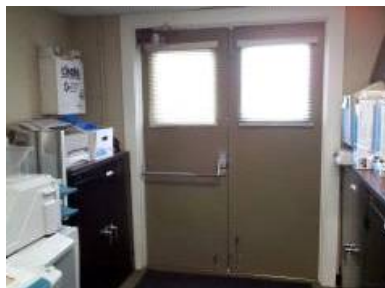
Photo #
247

Existing Condition: 9 LBF.

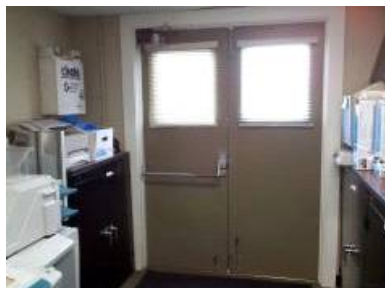
Photo #
247

Field Condition

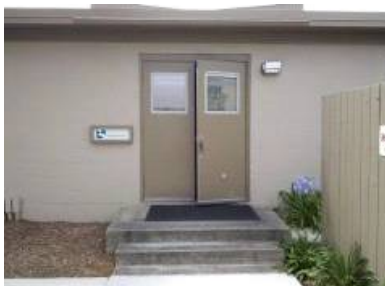
Photo #
250

Existing Condition: 54" AFF.

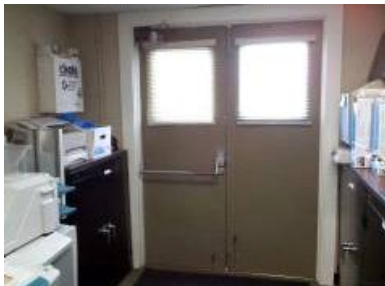
Photo #
247

Existing Condition: Pinching latch lock.

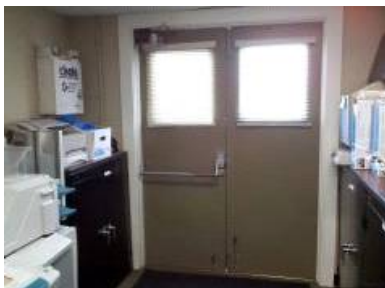
Photo #
247

Existing Condition: Latch lock at 75" AFF.

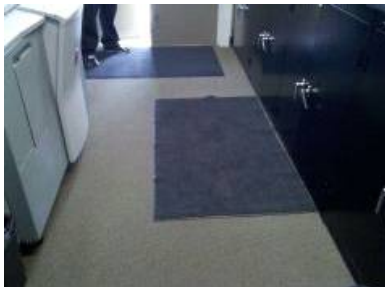
Photo #
262

Existing Condition: Floor mat.

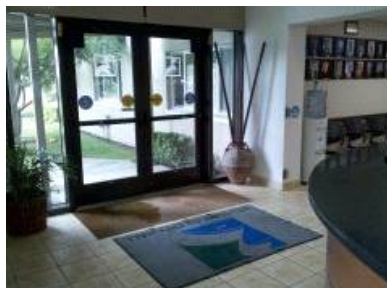
Photo #
263

Existing Condition: 2 floor mats

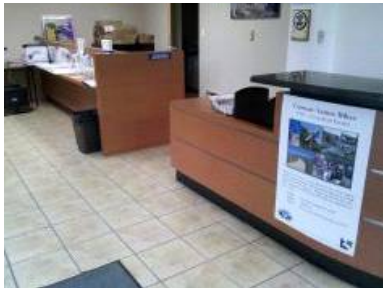
Photo #
264

Existing Condition:

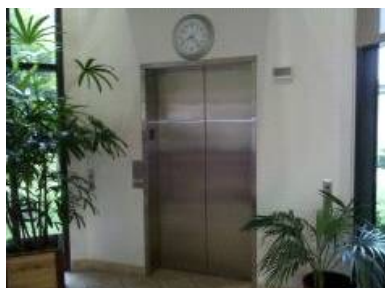
Location: Admin. - Elevator
Photo # 267

13.04A - Call Buttons - Mounting Height - The hallway call buttons are not centered at 42" above the floor.

Existing Condition: 42 1/4" high at 1st flr. & 41 1/2" at 2nd flr.

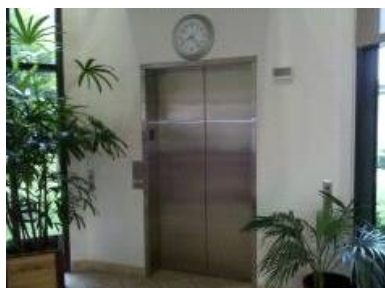
Location: Admin. - Elevator
Photo # 267

13.05B - Call Buttons - Internal Illumination - The hall call buttons are not internally illuminated with a white light over the entire surface of the button.

Existing Condition: illuminated w/ red light

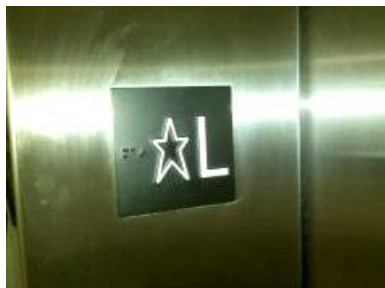
Photo #
270

Existing Condition: Braille space to wide at 1st & 2nd floor

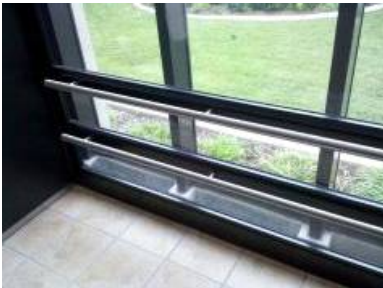
Photo #
271

13.16A - Handrail - There is no handrail installed at 32" AFF (+/-1").
Existing Condition: 31" AFF.

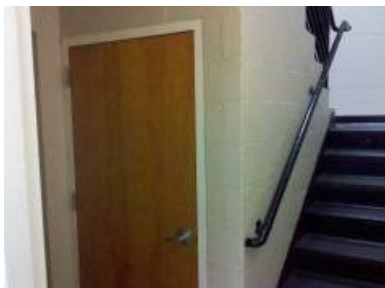
Photo #
273

11.06A - Door Maneuvering Space - Door that is not automatic or power-assisted does not have compliant maneuvering space relative to the direction of approach as shown in CBC Fig. 11B-26. (Approach // Side // Width // Depth) (Front // Pull // D + 24" * // 60") (Front // Push // D + 0" ** // 48") (Latch // Pull // D + 24" // 60") (Latch // Push // D + 24" // 44" ***) (Hinge // Pull // D + 36" // 60") (Hinge // Push // 54" **** // 44" *****) (* D + 18" at interior doors.) (** D + 12" if door has both a latch and a closer.) (***) 48" if door has closer.) (**** Measured from latch toward hinge.) (***** 48" if door has both a latch and a closer.)

Existing Condition: 42 1/2" deep landing at pull side

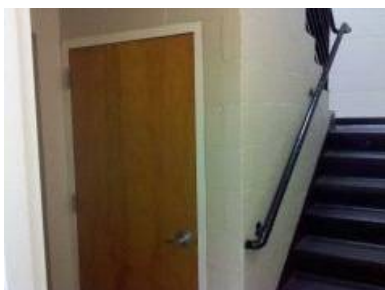
Photo #
273

Existing Condition: 78 1/2" at door

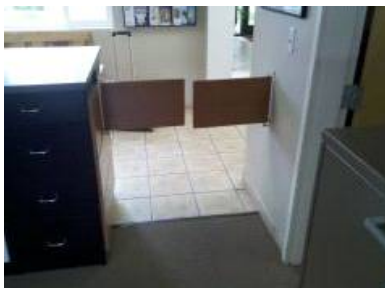
Photo #
274

Existing Condition: 18" wide gate & 26 3/4" toe space.

054A - Replace Door - Remove existing door and replace with new door and door frame. Provide new accessible door hardware.

Additional Comments: replace with one compliant gate.

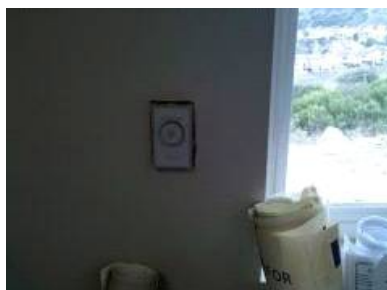
Photo #
275

Existing Condition: Twist type thermostat

031B - Replace Control - Replace control. Repair/refinish as required.

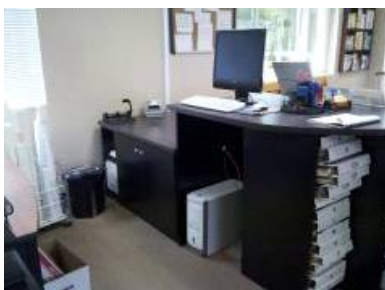
Photo #
276

Existing Condition: 20" wide

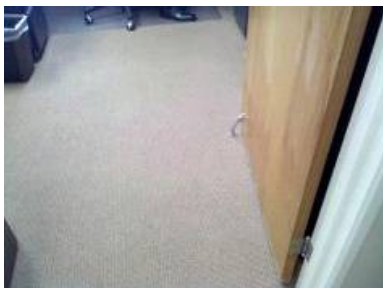
Location: Admin. - Office
Photo # 299

11.15A - Kick Plate - Bottom 10" of door does not have a smooth, uninterrupted surface on the push side to allow the door to be opened by a wheelchair footrest without creating a trap or hazardous condition. (This requirement does not apply to automatic and sliding doors.)

Existing Condition: Door stop

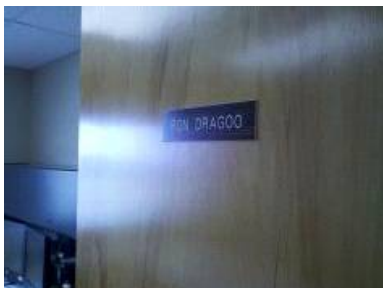
Location: Admin. - Office
Photo # 300

11.17B - Room/Space Identification Signs (Visual/Tactile Signs) - Sign designating the permanent room or space does not comply with ADAAG and CBC requirements for tactile signs.

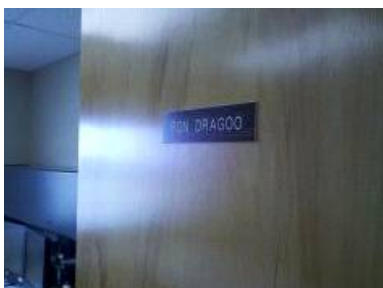
11.23A - Mounting Location (Visual/Tactile Signs) - Sign is not mounted on the wall adjacent to the latch side of the door. OR At double leaf doors, the sign is not placed on the nearest adjacent wall.

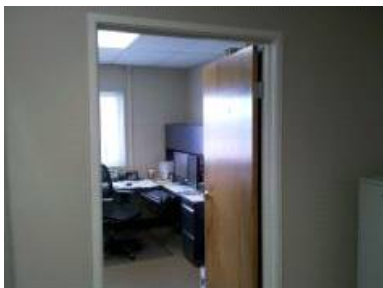
14.31 - Head Room - Clear head room is at less than 80" within the pedestrian circulation area, including the accessible route of travel.

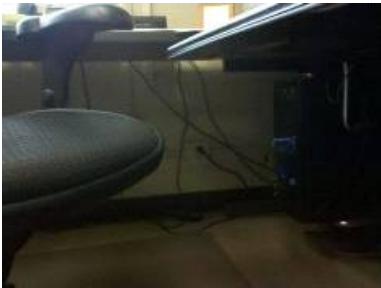
Location: Admin. - Office
Photo # 303

14.32A - Reach Range - Controls - Controls, dispensers, and similar devices are not between 9" and 54" AFF when the clear floor space allows a parallel approach. OR They are not between 15" and 48" AFF when the clear floor space allows only a forward approach.

Existing Condition: 3 outlets

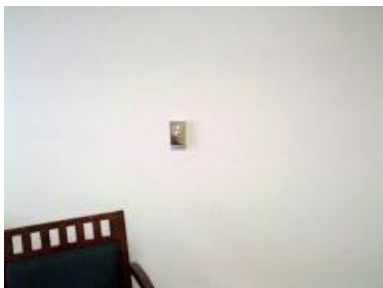
Photo #
307

14.32A - Reach Range - Controls - Controls, dispensers, and similar devices are not between 9" and 54" AFF when the clear floor space allows a parallel approach. OR They are not between 15" and 48" AFF when the clear floor space allows only a forward approach.

Existing Condition: 3 outlet & 3 Data, 1 thermostat

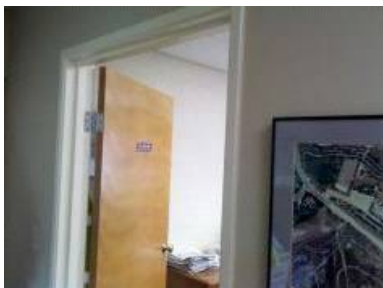
14.31 - Head Room - Clear head room is at less than 80" within the pedestrian circulation area, including the accessible route of travel.

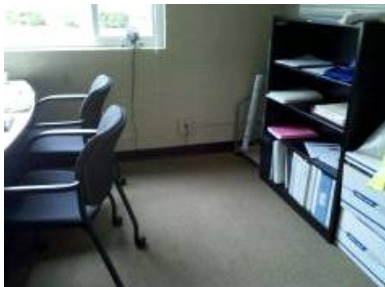
Keynote 312

14.32A - Reach Range - Controls - Controls, dispensers, and similar devices are not between 9" and 54" AFF when the clear floor space allows a parallel approach. OR They are not between 15" and 48" AFF when the clear floor space allows only a forward approach.

Existing Condition: 3 outlet & 3 data

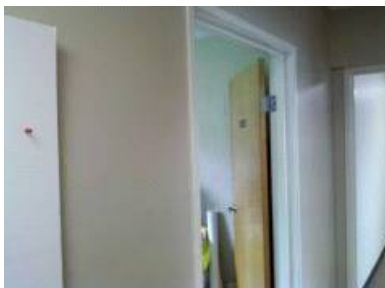
Keynote 313

14.31 - Head Room - Clear head room is at less than 80" within the pedestrian circulation area, including the accessible route of travel.

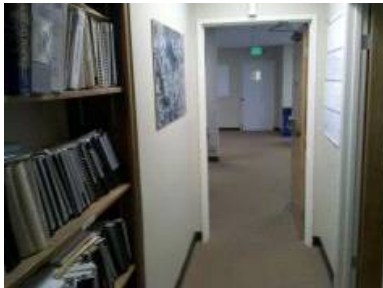
Keynote 314

11.06A - Door Maneuvering Space - Door that is not automatic or power-assisted does not have compliant maneuvering space relative to the direction of approach as shown in CBC Fig. 11B-26. (Approach // Side // Width // Depth) (Front // Pull // D + 24" * // 60") (Front // Push // D + 0" ** // 48") (Latch // Pull // D + 24" // 60") (Latch // Push // D + 24" // 44" ***) (Hinge // Pull // D + 36" // 60") (Hinge // Push // 54" **** // 44" *****) (* D + 18" at interior doors.) (** D + 12" if door has both a latch and a closer.) (***) 48" if door has closer.) (**** Measured from latch toward hinge.) (***** 48" if door has both a latch and a closer.)

Existing Condition: 4" push side

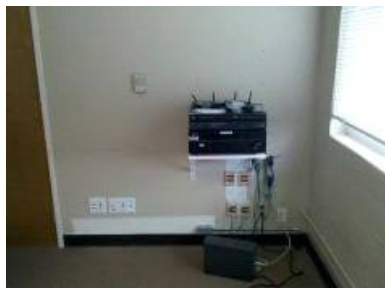
Keynote 321

Existing Condition: 16" deep at 31" high audio equipment

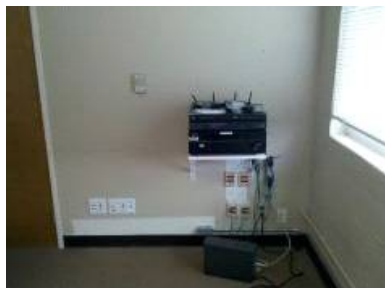
Keynote 322

Existing Condition: 5 outlets, 4 data, 3 audio

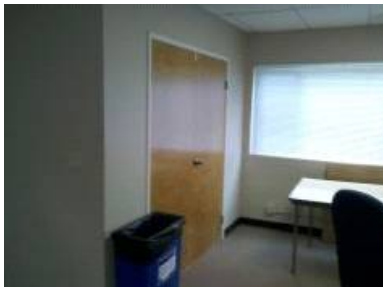
Keynote 324

11.11 - Single-Action Hardware - Handles, locks, and latches or other operative devices are not operable with one hand and without tight grasping, pinching, or twisting of the wrist. (U-shaped handles, levers, and push/pull type mechanisms are acceptable designs.)

067A - Replace Knob(s) with Lever Hardware - Remove knobs and existing latch and lock set. Provide new levers with new latch and lock sets.

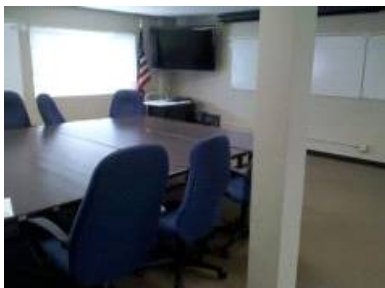
Keynote 325

15B.19 - Assistive Listening Systems (ALS) - For assembly areas without fixed seats (e.g., conference or meeting rooms), a permanently installed assistive listening system or a portable assistive listening system, including an adequate number of electrical outlets or other supplementary wiring necessary to support a portable ALS, has not been provided. (A permanently installed ALS is required where (1) the assembly area accommodates 50 or more persons or has an audio-amplification system and (2) it has fixed seats.) (If portable assistive-listening systems are used for conference or meeting rooms, the system may serve more than one room.)

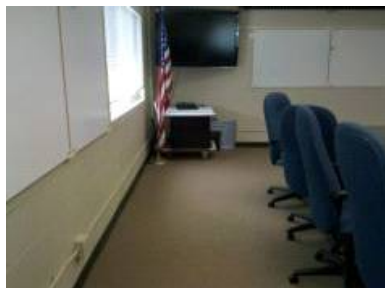
Keynote 326

14.30A - Wall-Mounted Protruding Objects - Wall-mounted object(s) with leading edges between 27 and 80" from the floor project more than 4" into the pathway. (Wall mounted objects with leading edges at or below 27" may project any amount as long as the required clear width of an accessible route is not reduced.)

Existing Condition: 4" at 53" high LCD screen

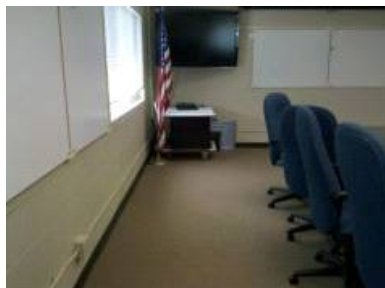
Keynote 327

14.32A - Reach Range - Controls - Controls, dispensers, and similar devices are not between 9" and 54" AFF when the clear floor space allows a parallel approach. OR They are not between 15" and 48" AFF when the clear floor space allows only a forward approach.

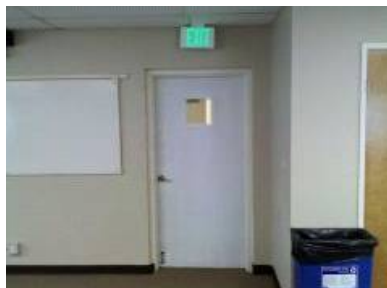
Keynote 328

Existing Condition: 7 lb.

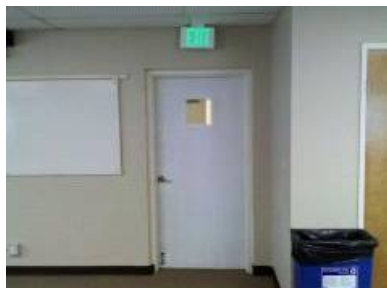
Keynote 329

11.15A - Kick Plate - Bottom 10" of door does not have a smooth, uninterrupted surface on the push side to allow the door to be opened by a wheelchair footrest without creating a trap or hazardous condition. (This requirement does not apply to automatic and sliding doors.)

Existing Condition: Door stop

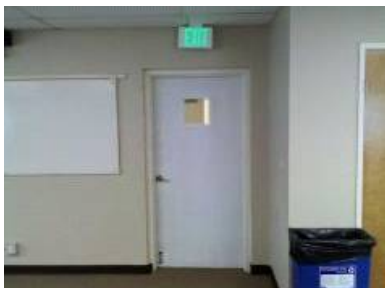
Keynote 330

11.15B_04AG - Vision Lights - Door, gate, or adjacent sidelight, containing one or more vision lights, does not include at least one vision light mounted with the bottom edge of the glazed panel at 43" max.. AFF. (Exception: Vision lights with the lowest part more than 66" AFF.)

Existing Condition: 59 3/4" high

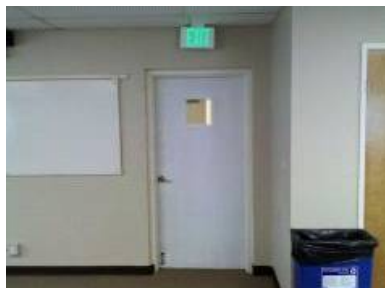
Keynote 333

Existing Condition: 79" at door

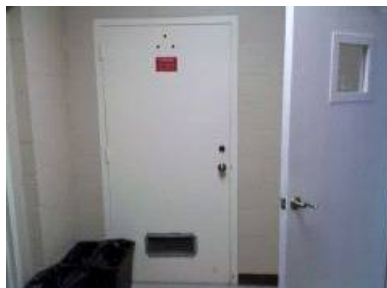
Keynote 334

Existing Condition: 78 1/2" at door

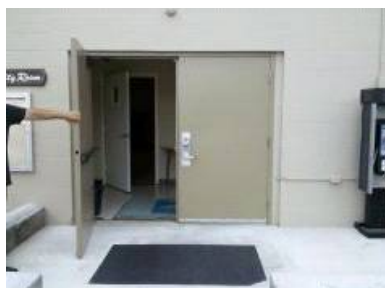
Keynote 336

10.02 - Entrance Sign - Accessible entrance is not identified by an ISA.

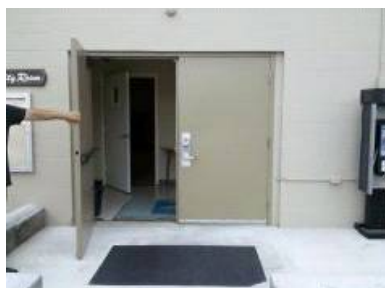
Keynote 337

10.07A - Landing - Level and Clear - Floor is not level (slope is greater than 2% in some or all directions). OR Floor is not clear within the required maneuvering space.

Existing Condition: 3.0% @ threshold & 2.7% at landing

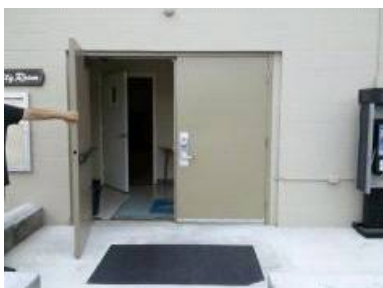
Keynote 338

10.11A - Door Operating Effort - The force required to operate door exceeds 5 lbs. (Fire doors may have up to 15 lbs to achieve positive latching).

Existing Condition: 10 lbs.

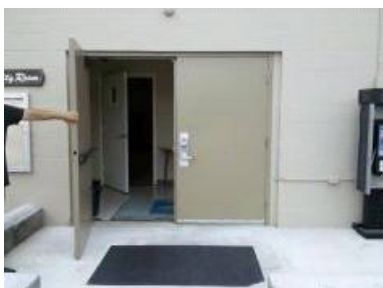
Keynote 339

11.13A - Door Operating Effort - The force required to operate door exceeds 5 lbs. (Fire doors may have up to 15 lbs to achieve positive latching).

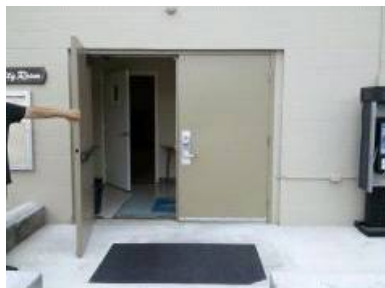
Keynote 341

14.23B - Floor Surface - Accessible route surfaces are not stable, firm and slip-resistant.

Existing Condition: 2 floor mats

075B - Surface-Mounted Walk-Off Mat - Remove existing walk-off mat and replace with new surface-mounted walk-off mat. Permanently attach mat to floor. Edges of mat shall be beveled with a slope no greater than 1:2 or shall not exceed 1/4" in height.

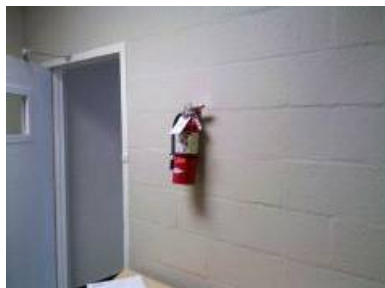
Keynote 343

Existing Condition: 64" high

388D - Relocate Fire Extinguisher - Relocate existing fire extinguisher. Repair and refinish.

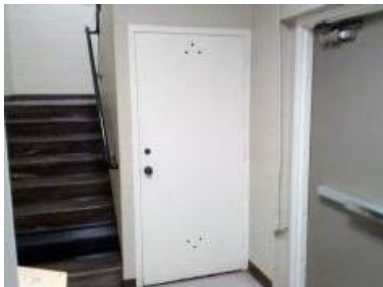
Keynote 345

Existing Condition: 78 1/2" at door

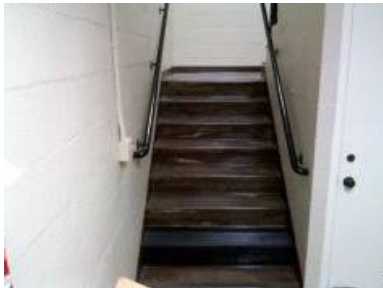
Keynote 346

08.04B - Interior Stairs - Color Strip Standards - Contrasting color strips are not compliant. (At interior stairs, CBC Standards require a solid contrasting color strip 2" wide parallel to and not more than 1" away from the nosing on the upper approach and the lower tread of the stairway. The strip shall be of material that is at least as slip resistant as the other treads of the stair.)

Existing Condition: 43" x 4

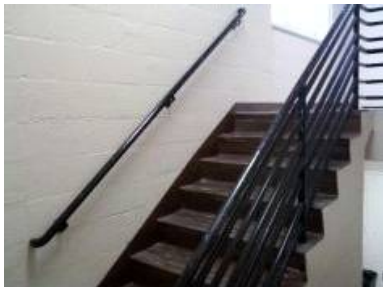
Keynote 347

08.09A - Handrail Extensions - Top Landing - At ends of handrails, less than 12" of handrail extends beyond the top nosing. (Top and bottom handrail extensions are important safety features for persons with balance problems and must extend in the direction of the stair run to permit the intended use.) (Per ADA/CBC Standards, in existing buildings and facilities, full extension of handrails at stairs shall not be required in alterations where such extensions would be hazardous or impossible due to plan configuration.)

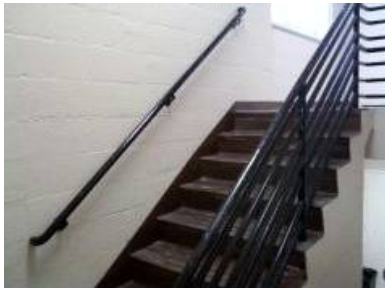
Keynote 348

08.09B - Handrail Extensions - Bottom Landing - At ends of handrails, less than 12" plus the tread width extends beyond the bottom nosing. (Top and bottom handrail extensions are important safety features for persons with balance problems and must extend in the direction of the stair run to permit the intended use.) (Per ADA/CBC Standards, in existing buildings and facilities, full extension of handrails at stairs shall not be required in alterations where such extensions would be hazardous or impossible due to plan configuration.)

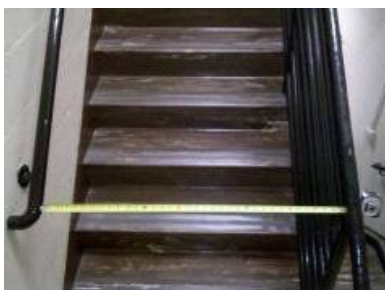
Keynote 352

Existing Condition: 35" wide.

257A - Replace Stairs - Replace stairs to comply with rise/run requirements.

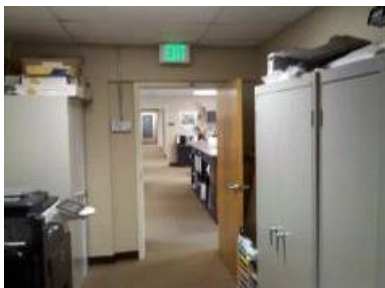
Keynote 354

11.13A - Door Operating Effort - The force required to operate door exceeds 5 lbs. (Fire doors may have up to 15 lbs to achieve positive latching).

Existing Condition: 12 LBF.

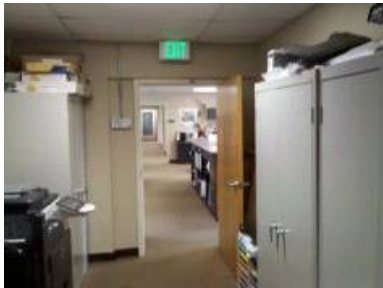
Keynote 355

11.21A - Required Exit Route Sign - At exit access door from an interior room or area that is required to have a visual exit sign, there is no tactile and CA Braille exit sign with the words "EXIT ROUTE" mounted on the wall adjacent to the latch side of the door. (Visual exit signs are required when two or more exits are required. Generally, all occupants shall have access to two exits from a floor (CBC Table 1019.1). Exceptions: a) Single story building with maximum occupant load of 49 and less than 75 ft travel distance to exit (CBC Table 1019.2), and b) Two story building with maximum occupant load of 30 occupants per floor and maximum travel distance of 75 ft to exit. (CBC Table 1019.2). Two exit access doors are required from an office tenant space when the occupant load exceeds 49.)

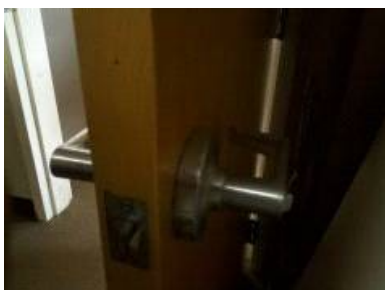
Keynote 356

Existing Condition: Twist-type locking mechanism.

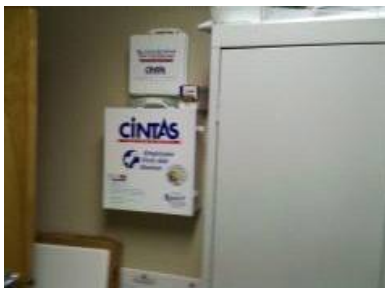
Keynote 357

Existing Condition: First aid kit at 65" AFF & infection control kit at 78" AFF.

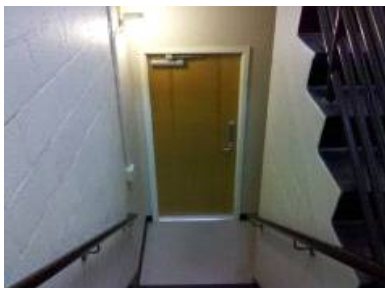
11.06A - Door Maneuvering Space - Door that is not automatic or power-assisted does not have compliant maneuvering space relative to the direction of approach as shown in CBC Fig. 11B-26. (Approach // Side // Width // Depth) (Front // Pull // D + 24" * // 60") (Front // Push // D + 0" ** // 48") (Latch // Pull // D + 24" // 60") (Latch // Push // D + 24" // 44" ***) (Hinge // Pull // D + 36" // 60") (Hinge // Push // 54" **** // 44" *****) (* D + 18" at interior doors.) (** D + 12" if door has both a latch and a closer.) (***) 48" if door has closer.) (**** Measured from latch toward hinge.) (***** 48" if door has both a latch and a closer.)

Existing Condition: 42 1/2" landing at push side, 51 1/2" landing at pull side.

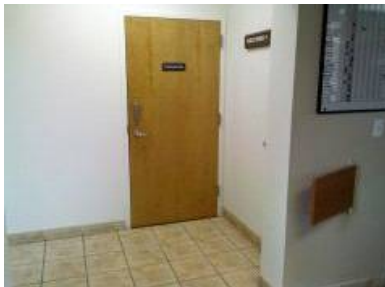
Photo #
361

Existing Condition: Key pad at 47 3/4" AFF.

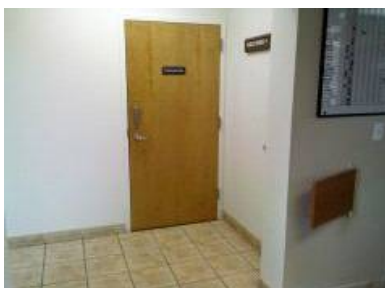
Photo #
361

Existing Condition: Door jamb at 78 3/4" AFF.

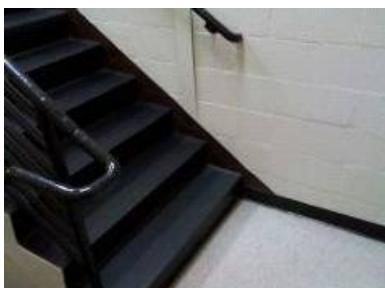
Photo #
365

Existing Condition: 46" X 4.

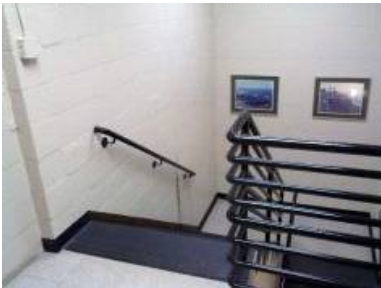
08.09A - Handrail Extensions - Top Landing - At ends of handrails, less than 12" of handrail extends beyond the top nosing. (Top and bottom handrail extensions are important safety features for persons with balance problems and must extend in the direction of the stair run to permit the intended use.) (Per ADA/CBC Standards, in existing buildings and facilities, full extension of handrails at stairs shall not be required in alterations where such extensions would be hazardous or impossible due to plan configuration.)

Existing Condition: Extensions not provided.

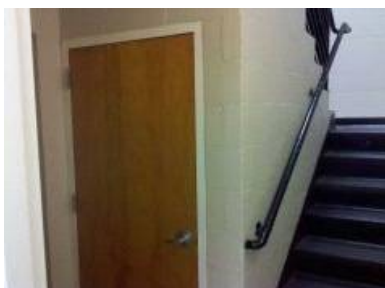
08.09B - Handrail Extensions - Bottom Landing - At ends of handrails, less than 12" plus the tread width extends beyond the bottom nosing. (Top and bottom handrail extensions are important safety features for persons with balance problems and must extend in the direction of the stair run to permit the intended use.) (Per ADA/CBC Standards, in existing buildings and facilities, full extension of handrails at stairs shall not be required in alterations where such extensions would be hazardous or impossible due to plan configuration.)

Existing Condition: Extensions not provided.

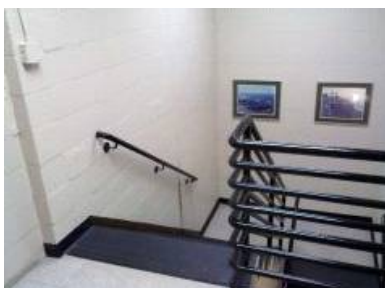
08.10A - Profile of Handrails - The diameter of the handrail is not between 1-1/4" and 1-1/2" in cross-sectional nominal dimension. OR The shape does not provide an equivalent gripping surface (equivalent gripping surfaces are 4" to 6-1/4" in perimeter, and 2-1/4" max. in any direction). (Note: Standard pipe sizes designated by the industry as 1-1/4" to 1-1/2" are acceptable).

Existing Condition: 1 3/4" diameter.

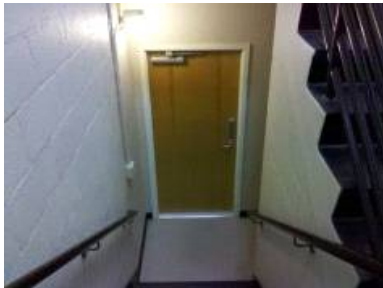
08.10B - Clearance - The clear space between handrails and walls is not 1-1/2" absolute. (ADA/CBC Standards apply an absolute dimension of 1-1/2", which provides knuckle clearance while generally disallowing entrapment of the forearm or elbow.)

Existing Condition: 2" clear.

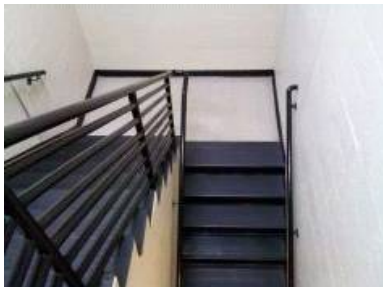
08.11A - 48" Stairway Width Standard - Stairway serving an area of rescue assistance is less than 48" wide between handrails.

Existing Condition: 39 3/4" clear.

257A - Replace Stairs - Replace stairs to comply with rise/run requirements.

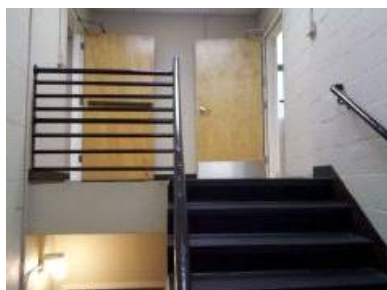
Location: Admin. - Stairwell
Photo # 369

Existing Condition: Not provided.

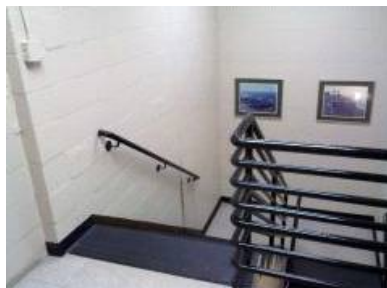
Location: Admin. - Stairwell
Photo # 364

Existing Condition: 32" above nosing.

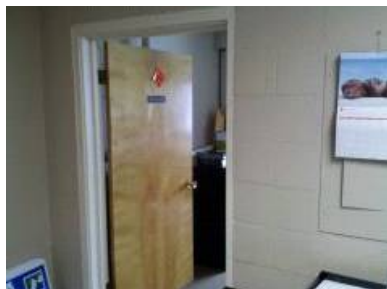
Photo #
372

Existing Condition: Door jamb at 77 1/2" AFF.

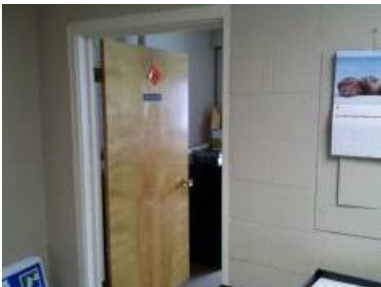
Photo #
372

Existing Condition: On door.

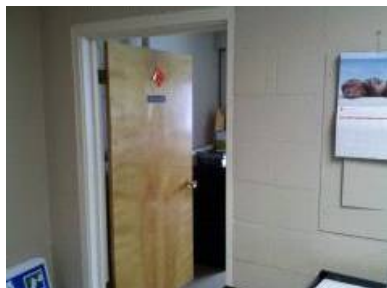
11.11 - Single-Action Hardware - Handles, locks, and latches or other operative devices are not operable with one hand and without tight grasping, pinching, or twisting of the wrist. (U-shaped handles, levers, and push/pull type mechanisms are acceptable designs.)

Existing Condition: Door knob.

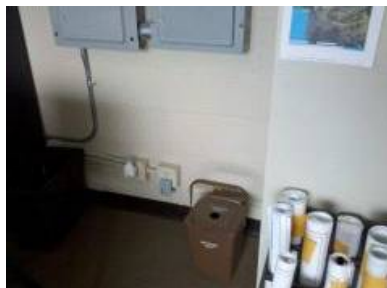
14.32A - Reach Range - Controls - Controls, dispensers, and similar devices are not between 9" and 54" AFF when the clear floor space allows a parallel approach. OR They are not between 15" and 48" AFF when the clear floor space allows only a forward approach.

Existing Condition: 5 power outlets.

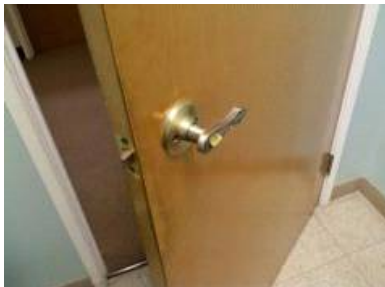
Photo #
378

Existing Condition: Twist-type locking mechanism.

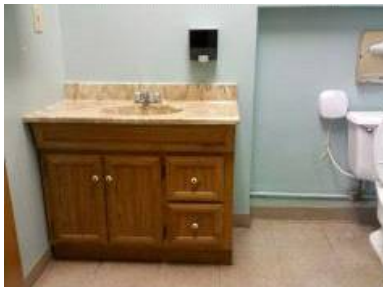
Photo #
382

Existing Condition: 51" diameter.

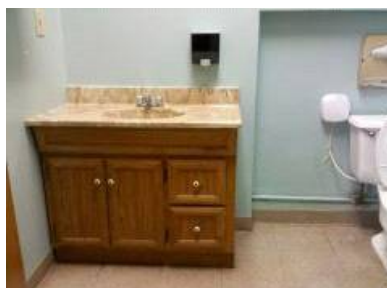
Location: Admin. - Men's Restroom
Photo # 382

Existing Condition: 25" clear.

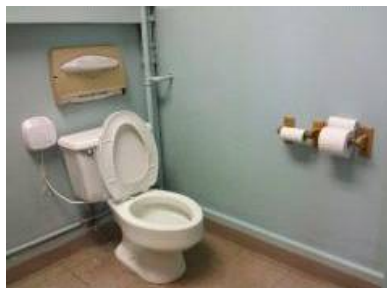
Location: Admin. - Men's Restroom
Photo # 384

Existing Condition: 17 1/2" from side wall.

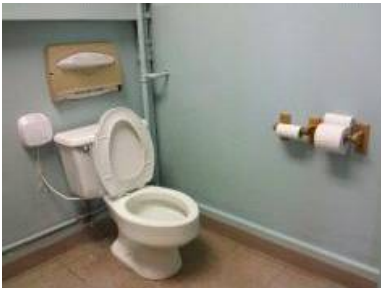
Photo #
384

16.48 - WC Seat Height - The top of the WC seat is not between 17" and 19" AFF.
Existing Condition: 15" AFF.

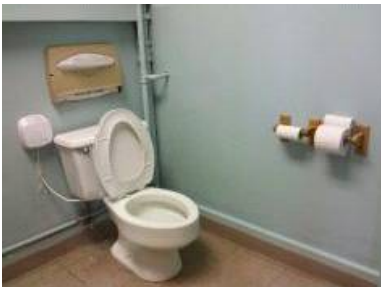
Photo #
384

16.53 - SC Dispenser Height - Mounting height of seat cover dispenser's highest operable part exceeds 40" AFF.
Existing Condition: 43" AFF.

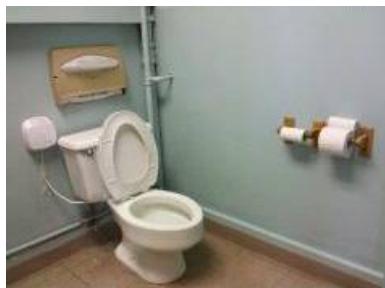
Photo #
384

Existing Condition: 20" & 51"

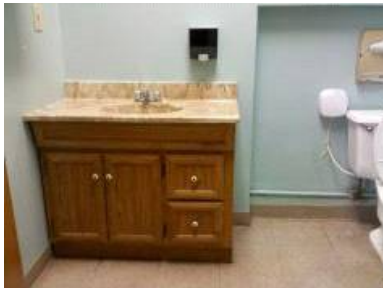
16.70 - Lavatories - Lavatory does not comply with ADAAG and CBC requirements. (ADA Standards require at least one lavatory to be accessible. CBC Standards prior to August 1, 2009 required all lavatories to be accessible. Effective August 1, 2009, amended CBC Standards require at least 5% of lavatories, but not less than one lavatory, to be accessible.)

Existing Condition: Knee space not provided.

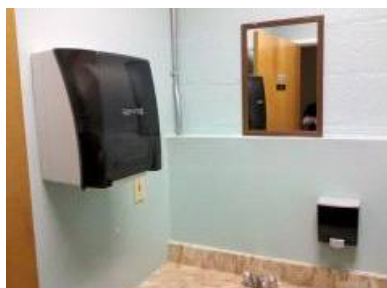
Location: Admin. - Men's Restroom
Photo # 391

Existing Condition: 56 1/2" AFF.

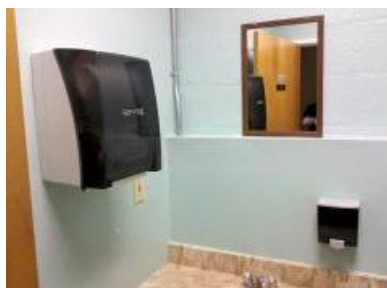
Location: Admin. - Men's Restroom
Photo # 391

Existing Condition: 53" AFF.

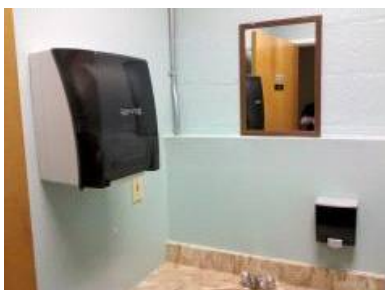
Location: Admin. - Men's Restroom
Photo # 391

Existing Condition: P.T.D. protrudes 5"

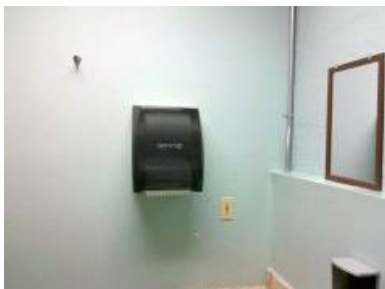
Location: Admin. - Men's Restroom
Photo # 394

Existing Condition: 75" AFF.

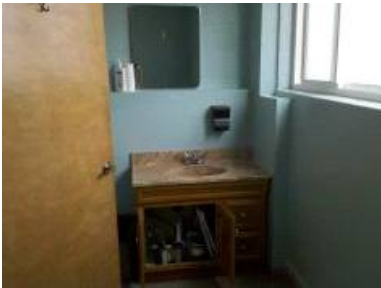
Keynote 401

16.09A - Door Maneuvering Space - Door that is not automatic or power-assisted does not have compliant maneuvering space relative to the direction of approach as shown in CBC Fig. 11B-26. (Approach // Side // Width // Depth) (Front // Pull // D + 24" * // 60") (Front // Push // D + 0" ** // 48") (Latch // Pull // D + 24" // 60") (Latch // Push // D + 24" // 44" ***) (Hinge // Pull // D + 36" // 60") (Hinge // Push // 54" **** // 44" *****) (* D + 18" at interior doors.) (** D + 12" if door has both a latch and a closer.) (***) 48" if door has closer.) (**** Measured from latch toward hinge.) (***** 48" if door has both a latch and a closer.)

Existing Condition: 8" to lavatory, pull side.

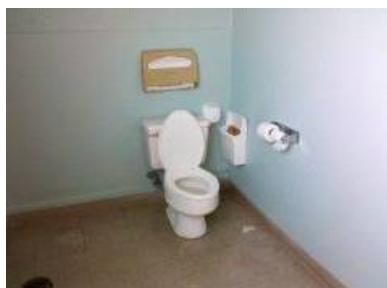
Keynote 402

Existing Condition: 20" from side wall.

319C - Water Closet - New Location - Replace existing water closet with compliant model in new location.

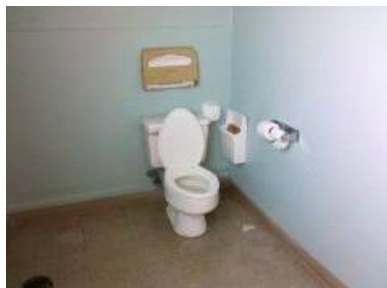
Keynote 403

Existing Condition: 15 1/2" AFF.

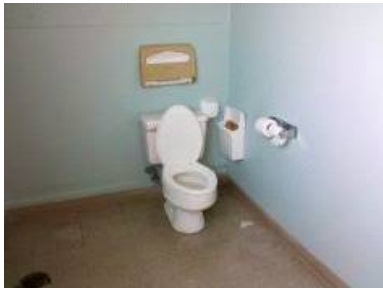
Keynote 404

16.53 - SC Dispenser Height - Mounting height of seat cover dispenser's highest operable part exceeds 40" AFF.

Existing Condition: 44" AFF.

294C - Relocate Dispenser - Relocate existing dispenser on an accessible route. Patch and repair wall substrate and finishes, to match adjacent undisturbed surfaces.

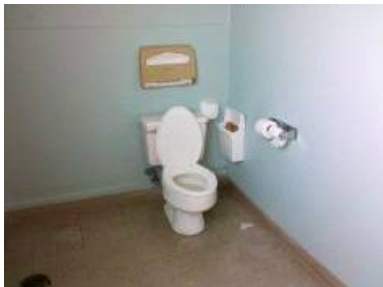
Keynote 405

16.54A - Grab Bar - Grab bar is not provided.

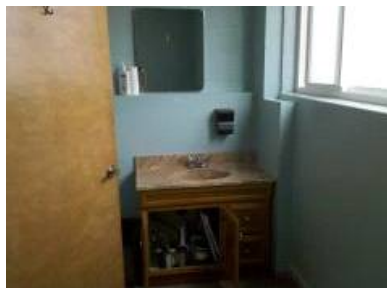
Keynote 407

16.70 - Lavatories - Lavatory does not comply with ADAAG and CBC requirements. (ADA Standards require at least one lavatory to be accessible. CBC Standards prior to August 1, 2009 required all lavatories to be accessible. Effective August 1, 2009, amended CBC Standards require at least 5% of lavatories, but not less than one lavatory, to be accessible.)

Existing Condition: Knee space not provided.

300C - Replace Lavatory - Replace existing lavatory with new compliant model.

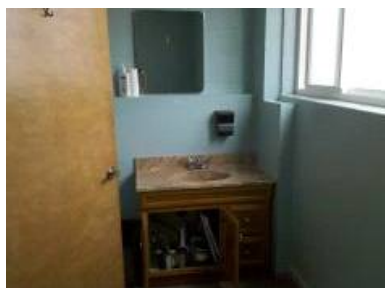
Keynote 408

16.82A - Mirror Height - Max. 40" AFF Standard - Mirror above accessible lavatory or countertop is mounted so the bottom edge of the reflective surface is not 40" max.. AFF. (ADA Standards require at least one mirror to be accessible; CBC Standards prior to August 1, 2009 required all mirrors to be accessible. Effective August 1, 2009, amended CBC Standards require all mirrors above accessible lavatories or countertops to be accessible.)

Existing Condition: 54" AFF.

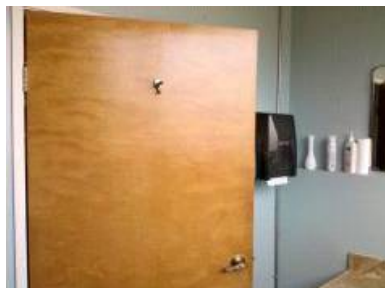
Keynote 409

16.84A - Paper Towel Dispenser - Operating Height - Mounting height of paper towel dispenser's highest operable part exceeds 40" AFF. (Where provided, ADA Standards require at least one paper towel dispenser to be accessible with the highest operable part placed within at least one of the reach ranges specified in 4.2.5 and 4.2.6; where provided, CBC Standards require at least one paper towel dispenser to be accessible with the highest operable part no higher than 40" AFF.)

Existing Condition: 52" AFF.

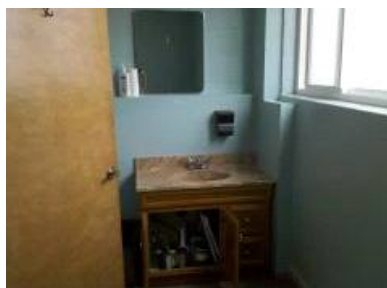
Keynote 410

16.84C - Soap Dispenser - Operating Height - Mounting height of soap dispenser's highest operable part exceeds 40" AFF. (Where provided, ADA Standards require at least one soap dispenser to be accessible with the highest operable part placed within at least one of the reach ranges specified in 4.2.5 and 4.2.6; where provided, CBC Standards require at least one soap dispenser to be accessible with the highest operable part no higher than 40" AFF.)

Existing Condition: 41" AFF.

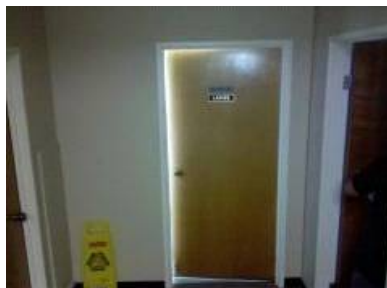
Keynote 411

11.15A - Kick Plate - Bottom 10" of door does not have a smooth, uninterrupted surface on the push side to allow the door to be opened by a wheelchair footrest without creating a trap or hazardous condition. (This requirement does not apply to automatic and sliding doors.)

Existing Condition: Door stop.

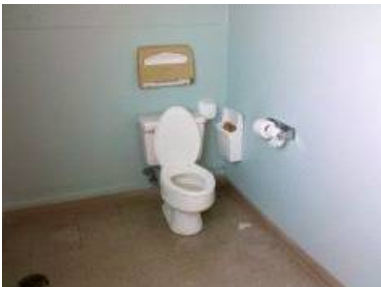
Keynote 413

Existing Condition: 3/4" change in level,

858A - Slip-Resistant Floor - Replace existing flooring with slip-resistant flooring.

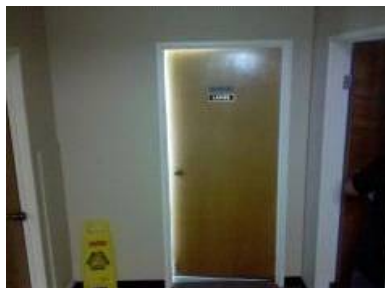
Keynote 414

Existing Condition: Door jamb at 77 1/2" AFF.

056 - Widen Door Opening - Remove existing door and replace with new door and door frame. Cut existing wall to widen door opening. Provide new accessible door hardware.

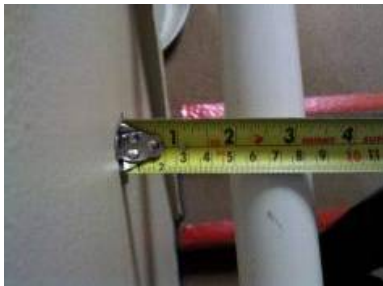
Keynote 419

08.10B - Clearance - The clear space between handrails and walls is not 1-1/2" absolute. (ADA/CBC Standards apply an absolute dimension of 1-1/2", which provides knuckle clearance while generally disallowing entrapment of the forearm or elbow.)

Existing Condition: 1 3/4" clear.

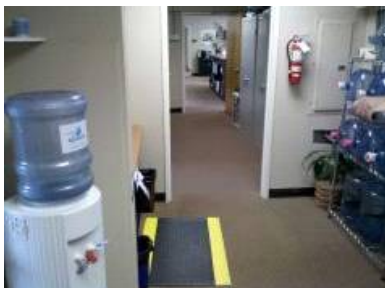
Keynote 421

Existing Condition: Floor mat.

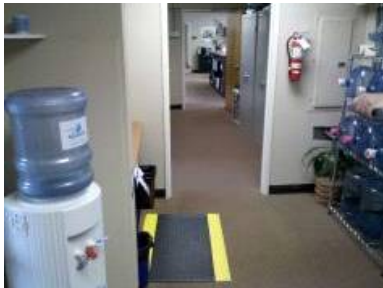
Keynote 422

Existing Condition: 61" AFF.

388D - Relocate Fire Extinguisher - Relocate existing fire extinguisher. Repair and refinish.

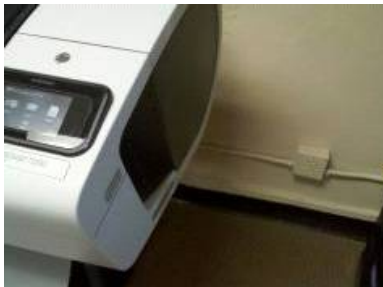
Keynote 423

Existing Condition: 4 power outlets at 13" AFF.

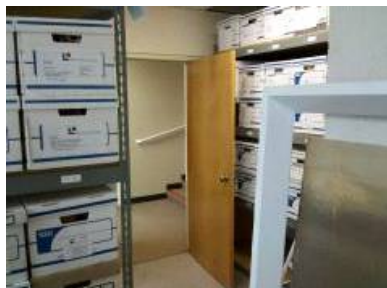
Keynote 425

Existing Condition: Door knob.

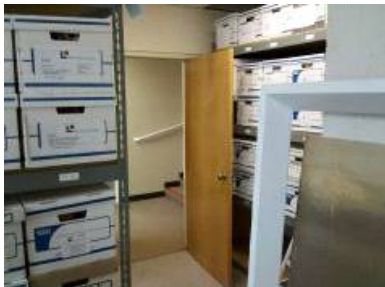
Keynote 427

Existing Condition: Door jamb at 77 1/4" AFF.

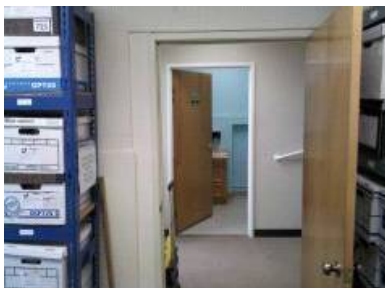
Keynote 428

11.06A - Door Maneuvering Space - Door that is not automatic or power-assisted does not have compliant maneuvering space relative to the direction of approach as shown in CBC Fig. 11B-26. (Approach // Side // Width // Depth) (Front // Pull // D + 24" * // 60") (Front // Push // D + 0" ** // 48") (Latch // Pull // D + 24" // 60") (Latch // Push // D + 24" // 44" ***) (Hinge // Pull // D + 36" // 60") (Hinge // Push // 54" **** // 44" *****) (* D + 18" at interior doors.) (** D + 12" if door has both a latch and a closer.) (***) 48" if door has closer.) (**** Measured from latch toward hinge.) (***** 48" if door has both a latch and a closer.)

Existing Condition: 14" to non-fixed shelving, pull side.

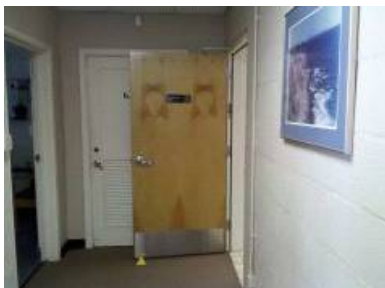
Keynote 429

11.06A - Door Maneuvering Space - Door that is not automatic or power-assisted does not have compliant maneuvering space relative to the direction of approach as shown in CBC Fig. 11B-26. (Approach // Side // Width // Depth) (Front // Pull // D + 24" * // 60") (Front // Push // D + 0" ** // 48") (Latch // Pull // D + 24" // 60") (Latch // Push // D + 24" // 44" ***) (Hinge // Pull // D + 36" // 60") (Hinge // Push // 54" **** // 44" *****) (* D + 18" at interior doors.) (** D + 12" if door has both a latch and a closer.) (***) 48" if door has closer.) (**** Measured from latch toward hinge.) (***** 48" if door has both a latch and a closer.)

Existing Condition: 9 3/4" pull side

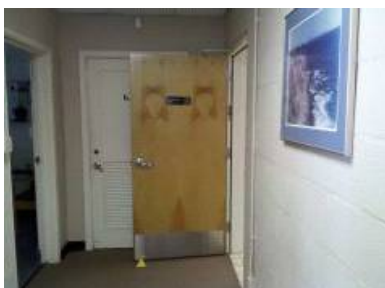
Keynote 430

Existing Condition: 77 1/2" at door

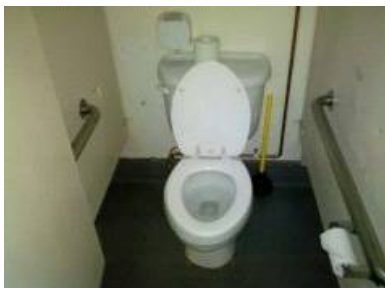
Keynote 431

Existing Condition: No accessible stall.

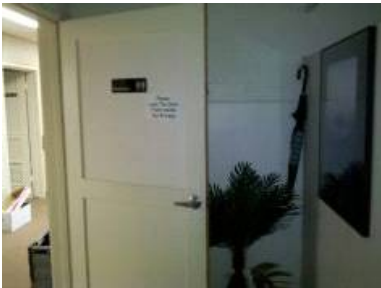
Keynote 432

16.09A - Door Maneuvering Space - Door that is not automatic or power-assisted does not have compliant maneuvering space relative to the direction of approach as shown in CBC Fig. 11B-26. (Approach // Side // Width // Depth) (Front // Pull // D + 24" * // 60") (Front // Push // D + 0" ** // 48") (Latch // Pull // D + 24" // 60") (Latch // Push // D + 24" // 44" ***) (Hinge // Pull // D + 36" // 60") (Hinge // Push // 54" **** // 44" *****) (* D + 18" at interior doors.) (** D + 12" if door has both a latch and a closer.) (***) 48" if door has closer.) (**** Measured from latch toward hinge.) (***** 48" if door has both a latch and a closer.)

Existing Condition: 53 1/2" Latch pull side

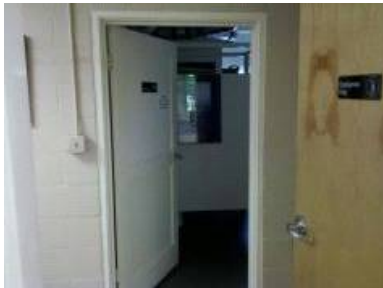
Keynote 433

16.13C - Unisex RR Geometric Symbol Signage - Circle/Triangle - Doorway leading to a unisex toilet room is not identified by a 12" circle, 1/4" with a 1/4" thick triangle superimposed and within the circle. OR Circle and triangle are provided, however they are accompanied by words in raised characters and Braille. (ADA and CBC Standards require a separate sign with raised characters and Braille mounted on the wall adjacent to the latch side of the door.)

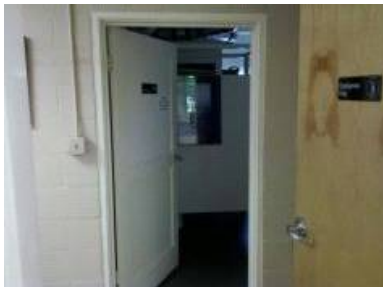
Keynote 434

16.15A - Providing Room/Space ID Sign - A sign designating the permanent room or space has not been provided.

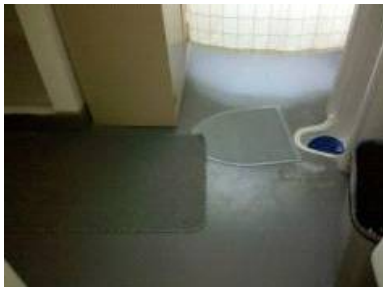
Keynote 436

16.27A - 60" Wide Circle or T-Shaped Maneuvering Space - The toilet room does not include an unobstructed turning space (a 60" diameter, 27" high circle or T-shaped space). (Note: The clear floor space of fixtures and controls, the accessible path of travel, and the turning space may overlap.)

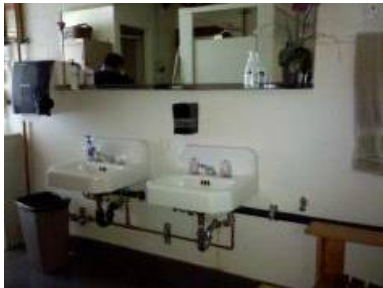
Keynote 437

Existing Condition: 27 1/2" high

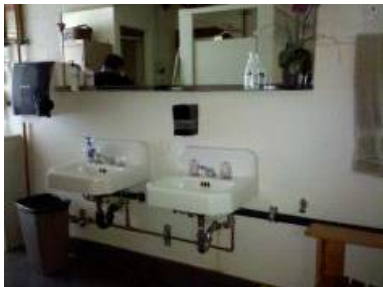
Keynote 438

Existing Condition: 25 1/4" high

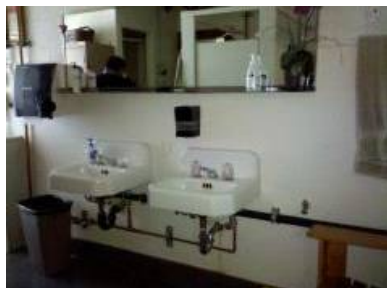
Keynote 441

16.82A - Mirror Height - Max. 40" AFF Standard - Mirror above accessible lavatory or countertop is mounted so the bottom edge of the reflective surface is not 40" max.. AFF. (ADA Standards require at least one mirror to be accessible; CBC Standards prior to August 1, 2009 required all mirrors to be accessible. Effective August 1, 2009, amended CBC Standards require all mirrors above accessible lavatories or countertops to be accessible.)

Existing Condition: 52 1/2" high

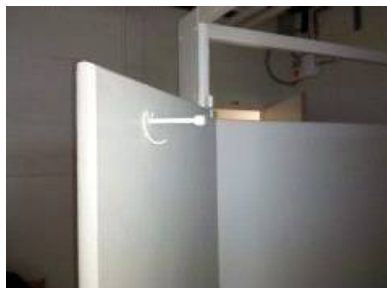
Keynote 442

16.83 - Coat Hook - Height - Where a coat hook is provided In an accessible stall, height of coat hook exceeds 48" AFF.

Existing Condition: 57" high

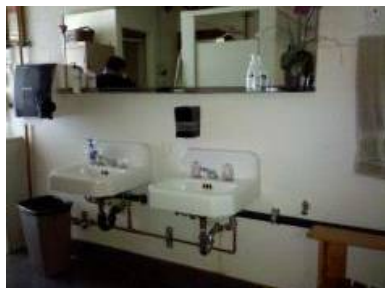
Keynote 444

16.84C - Soap Dispenser - Operating Height - Mounting height of soap dispenser's highest operable part exceeds 40" AFF. (Where provided, ADA Standards require at least one soap dispenser to be accessible with the highest operable part placed within at least one of the reach ranges specified in 4.2.5 and 4.2.6; where provided, CBC Standards require at least one soap dispenser to be accessible with the highest operable part no higher than 40" AFF.)

Existing Condition: 41" high

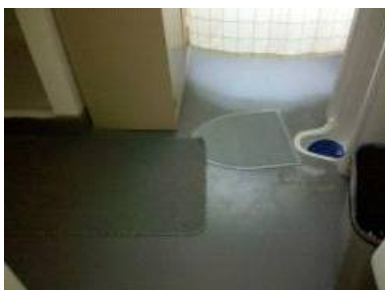
Keynote 445

Existing Condition: 43" deep clr floor space

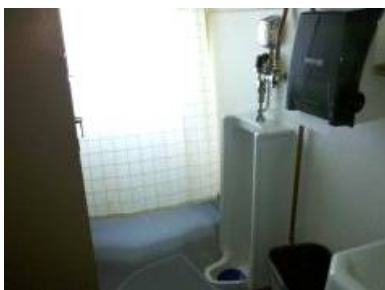
Location: Admin. - Unisex Restrm.
Photo # 443

Existing Condition: 52" high

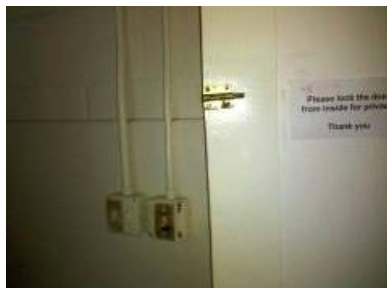
14.32A - Reach Range - Controls - Controls, dispensers, and similar devices are not between 9" and 54" AFF when the clear floor space allows a parallel approach. OR They are not between 15" and 48" AFF when the clear floor space allows only a forward approach.

Existing Condition: 53" high power switch

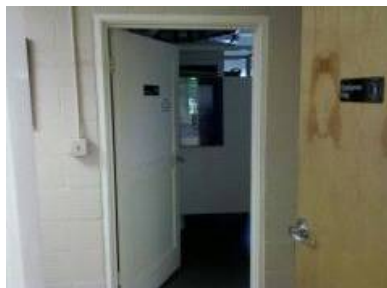
14.31 - Head Room - Clear head room is at less than 80" within the pedestrian circulation area, including the accessible route of travel.

Existing Condition: 77 1/2" at door

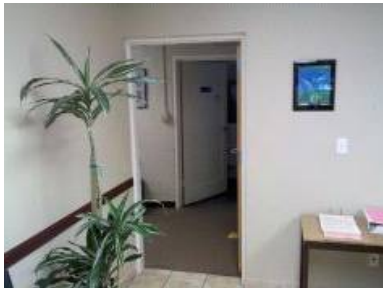
11.06A - Door Maneuvering Space - Door that is not automatic or power-assisted does not have compliant maneuvering space relative to the direction of approach as shown in CBC Fig. 11B-26. (Approach // Side // Width // Depth) (Front // Pull // D + 24" * // 60") (Front // Push // D + 0" ** // 48") (Latch // Pull // D + 24" // 60") (Latch // Push // D + 24" // 44" ***) (Hinge // Pull // D + 36" // 60") (Hinge // Push // 54" **** // 44" *****) (* D + 18" at interior doors.) (** D + 12" if door has both a latch and a closer.) (***) 48" if door has closer.) (**** Measured from latch toward hinge.) (***** 48" if door has both a latch and a closer.)

Existing Condition: 6" at push side

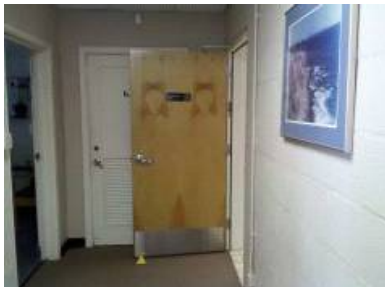
Photo #
453

Existing Condition: 9 Lb

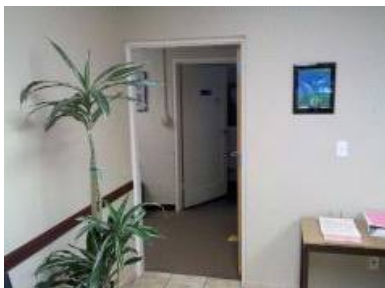
Photo #
452

Existing Condition: 77 1/2" at door

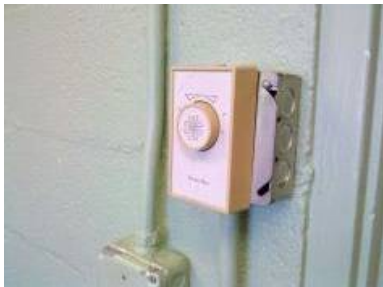
Photo #
460

Existing Condition: 1 outlet, 1 power strip, & 57" high thermostat.

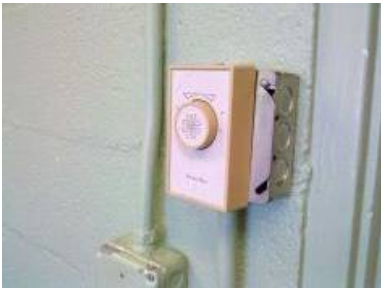
14.35 - Controls - Operation - The controls are not accessible. (Accessible controls shall be operable with one hand, and without tight grasping, pinching, or twisting of the wrist, and the force to operate the controls shall be no greater than 5 lbs.)

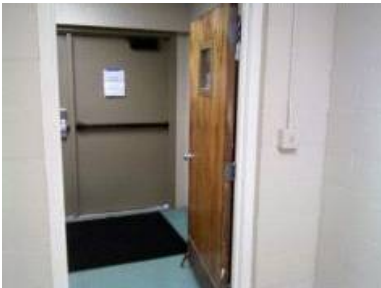
Photo #
463

Existing Condition: knob

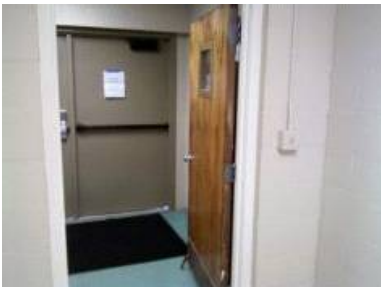
Photo #
463

Existing Condition: 6 Lb

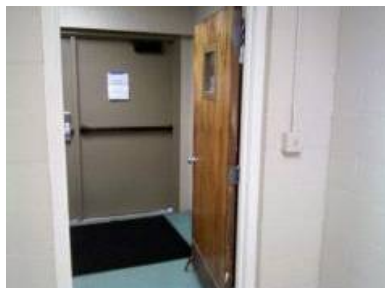
11.15A - Kick Plate - Bottom 10" of door does not have a smooth, uninterrupted surface on the push side to allow the door to be opened by a wheelchair footrest without creating a trap or hazardous condition. (This requirement does not apply to automatic and sliding doors.)

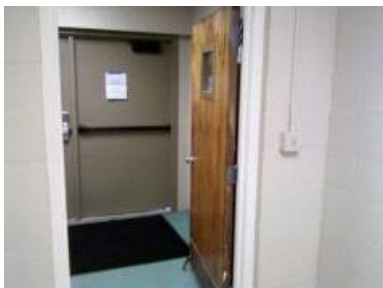
Photo #
463

Existing Condition: 59" high

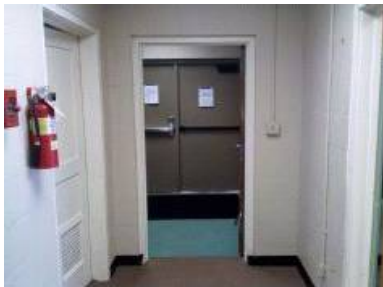
Photo #
468

Existing Condition: 77 1/2" high
